DICRONITE®

Anti-Galling/ Run-In Torque Reduction

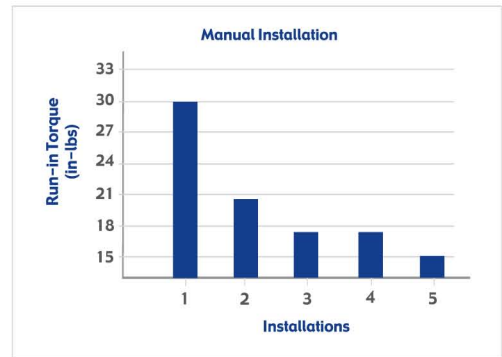
- A set of Diconite dry lubricated bolts and nutplates were prepared for testing.
- Manual Installation: As shown in Figure 1, the run-in torque was low and decreased with every installation/removal cycle. No evidence of galling was noted and the coating was found to be in good condition throughout the test.

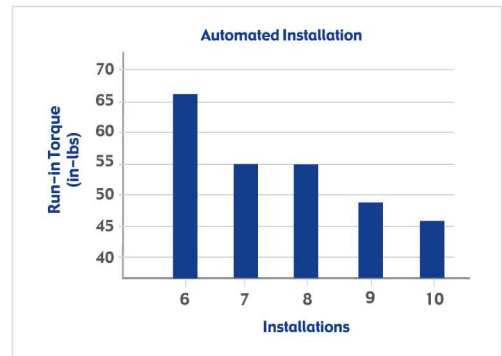
- Automated Installation: The run-in torque measured after the 5th cycle was 32 in-pounds and no evidence of galling or coating loss was noted. The data from the subsequent five cycles (#s 6-10) is shown in Figure 2. Interestingly the 6th cycle run-in torque was higher but then consistently decreased with each cycle. No evidence of galling was noted throughout; minimal coating degradation was observed.
